# **Internal Coating of Air-Cooled Gas Turbine Blades**

**Final Report**

L. Hsu and A.R. Stetson

**SOLAR TURBINES INTERNATIONAL**

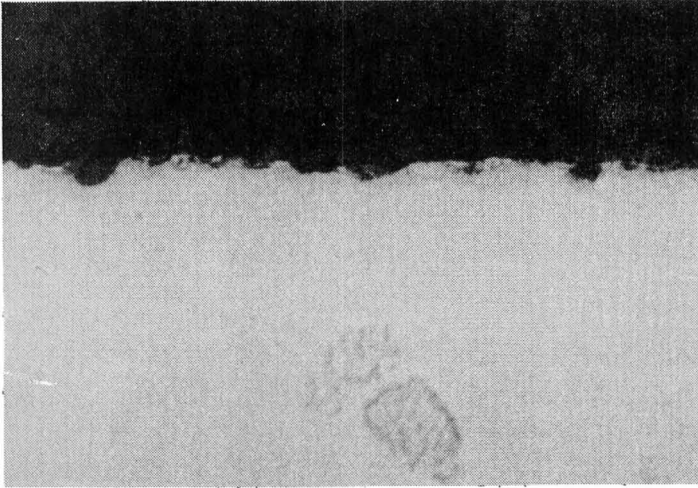
Magnification: 500X

2% Chromic Etch

In any coating process, surface preparation prior to application is considered an integral and critical part of the entire process. This is especially true in internal coating application where the surface finish and conditions cannot be readily viewed, as exemplified by the Mars stage 1 blade shown in Figure 3. Several methods of surface preparation were investigated for cleanup of internal as-cast surface, a typical example of which is shown in Figure 30.

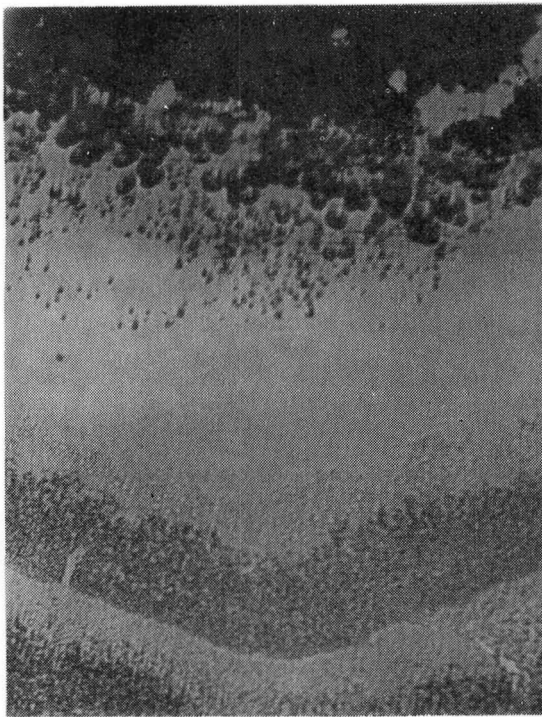
Blade No. N9

Ni-19Al-1Cb Coating

Figure 40. Comparison of Coating Thickness Along Blade Axis

The Ni-19Al-1Cb coated blade, N9, was further sectioned and examined, as shown in Figure 40. Besides the decrease in thickness noted in the trailing edge holes, a small gradient in coating thickness was also observed in the blade tip to firtree direction. Coating thickness appeared to be considerably greater in area A, 200-240 microns (see Fig. 40) compared to 140 microns in areas marked B, C, and D. Little change was observed in the coating along the vertical axis as the bore diameter remained constant. Again, this confirms that since coating thickness is governed by the internal capacity of the blade.

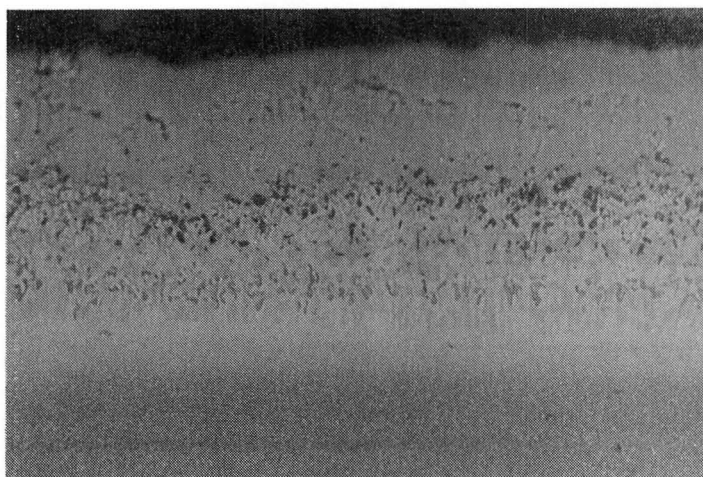
Figure 82. Typical Microstructures of Internally and Externally Coated (Ni-12Al-20Cr) IN-792 Blade at Trailing Edge (Specimen A53)

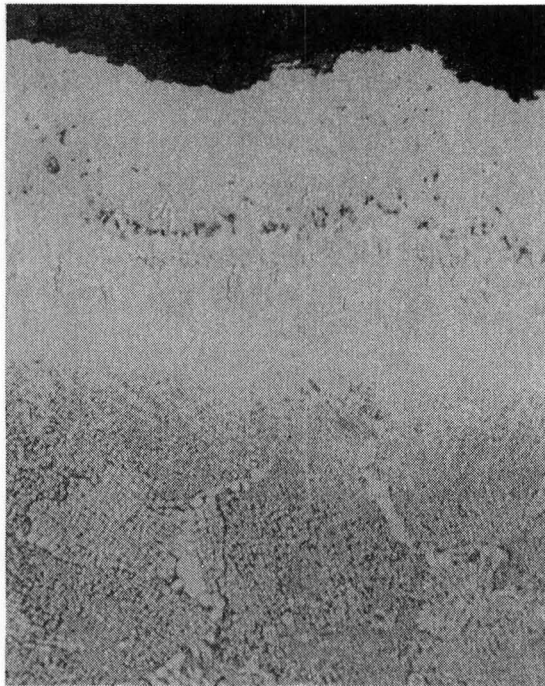
Near Leading Edge

Figure 88. Microstructures of External Surfaces of Uncoated IN-792 + Hf Blades After 500 Hours of Engine Testing (Specimen A15)

Comparison of coated and uncoated IN-792 + Hf alloy can be made with reference to Figure 88 (at half the magnification) which shows the external surfaces of the unprotected alloy. Near the leading edge which bears the brunt of the hot gases from the combustor, intergranular oxidation (IGO) was found to extend 200 to 300 microns into the alloy with the depleted zone essentially losing all of its gamma/gamma prime structure. Similar, though less extensive, degradation was observed near the edge. Therefore, oxidation attack can be significantly alleviated by the Ni-19Al-3Cb coating which generally shows less than 50 microns attack under similar conditions except for the brittle thermal fatigue induced cracks at localized areas.

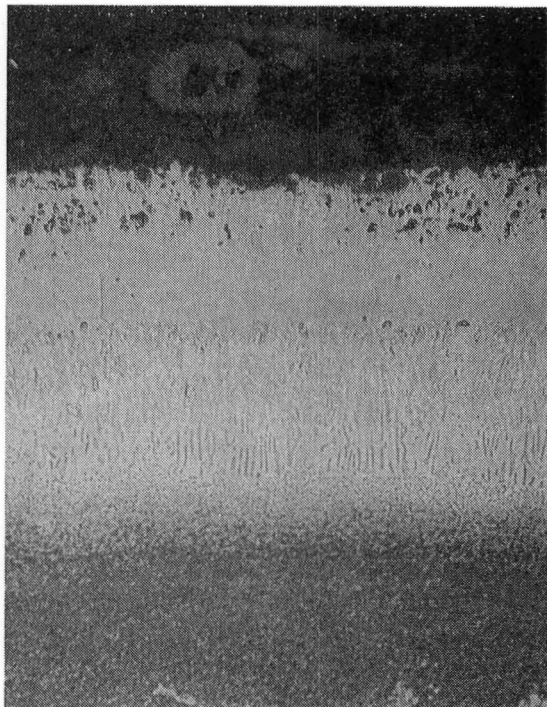
Specimen R4 - Washed  
Mount No. 288

Figure C-2.

Variation A (Batch 2)  
Ni-19Al-1Cb

Magnification: 400X

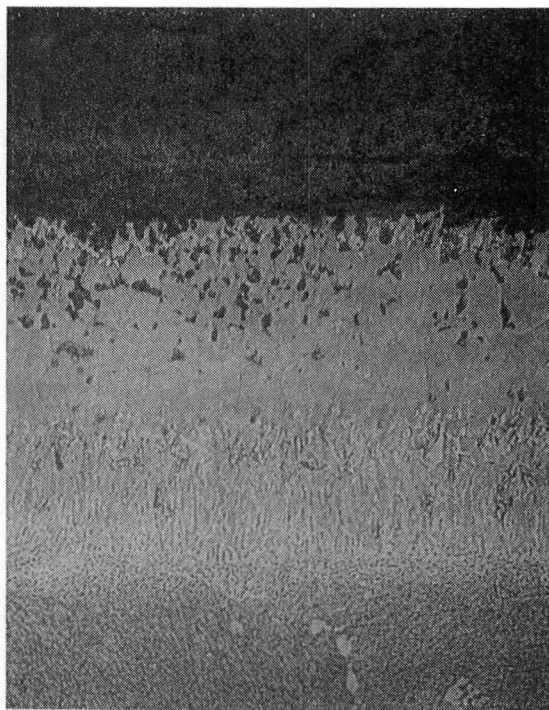
Specimen R14 - 318 Hours

Figure C-10.
